**AMC White Mountain Professional Trail Crew & 4,000 Footer Committee Repair Falling Waters Trail Treadway**

**Report prepared by the AMC Trails Department 2013-2014**

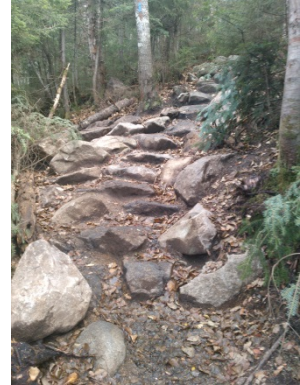
Major erosion had occurred at the turn of the first switchback, resulting in a sloping tread toward the steep slope off trail. The first few log checks steps were becoming undermined and had great potential of failure. Crews replaced and repaired the initial log steps and reinforced the trail at the base of the steps to prevent further erosion.

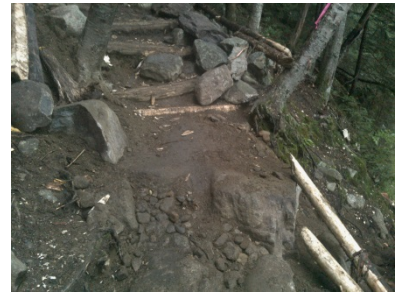
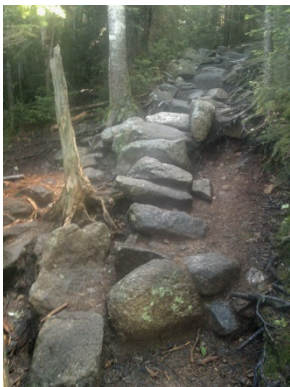
A second area of notable work was the repair of a rock staircase that exhibited what erosion can achieve. A 15-20 step rock staircase had become a floating island of stacked rock that provided no benefit to hikers. The result was tread widening and erosion to either side of the structure. In roughly two weeks time the crew was able to completely restore the staircase and bring its functionality back to life. The photo at the top is the repaired staircase, the photo to the left was prior to reconstruction efforts.
